## Action Log Report

Watercourse realignment, Sherridon mine remediation project, Sherridon  
Habitat File No: 17-HCAA-00076

### Sherridon Sampling – May 2019 – Summary

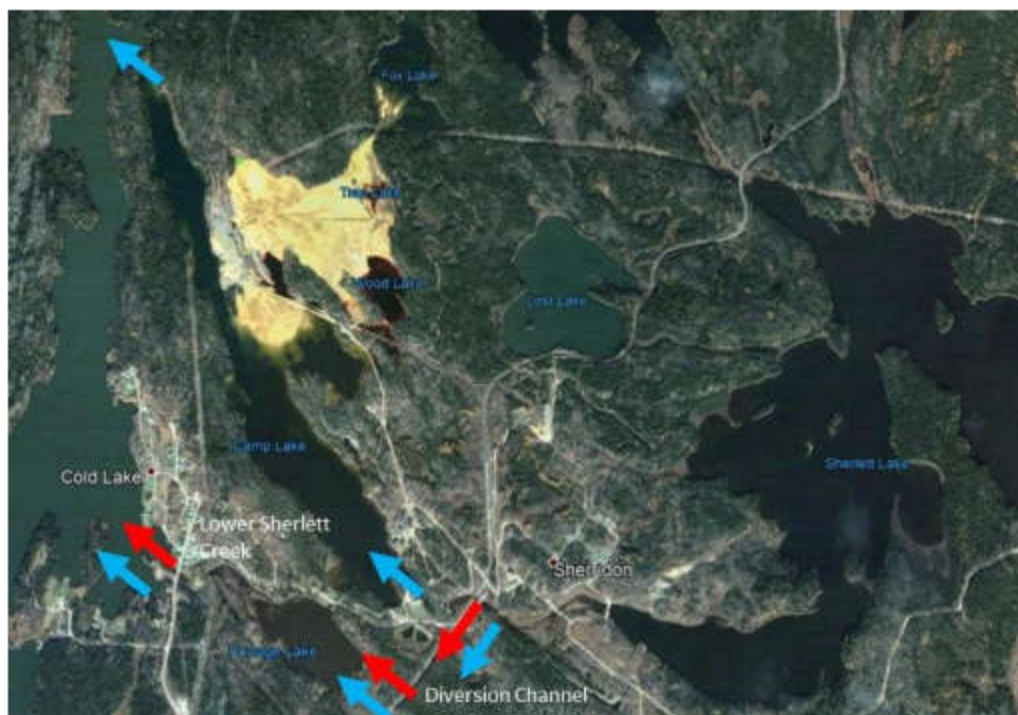
- Prior to 2019, water flowed following the red arrows (see above). Camp Lake which was used for mine tailings was isolated from the main flow coming from Sherlett Lake and a diversion channel pushed water through Portage Lake, Lower Sherlett Creek and eventually Cold Lake (Kississing Lake). As of summer 2018, under LOA 17-HCAA-00076, water was split between the diversion channel and back into Camp Lake and into Cold Lake to complete the remediation of the Camp Lake (blue arrows);

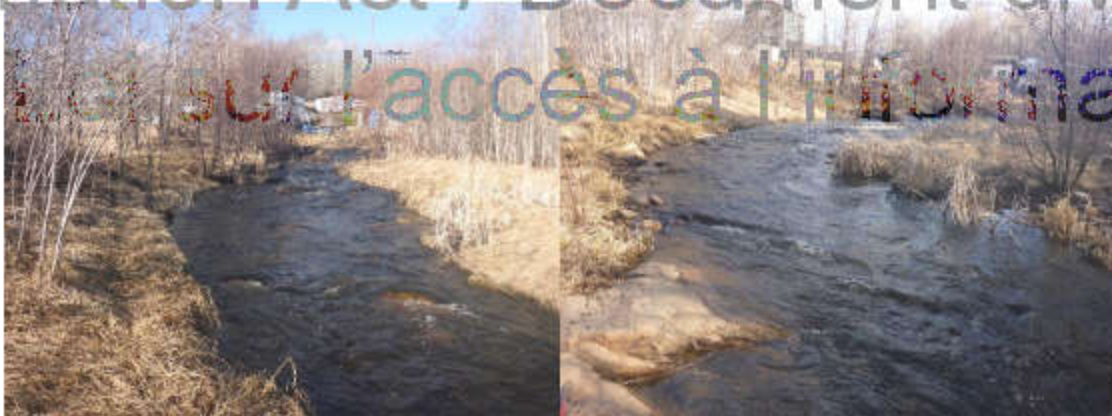
- On average, wetted width in Lower Sherlett Creek was similar to previous years (DFO and Tetratech sampled; around 5 m). Water velocity at 60% depth ranged from 0.20 m/s in back-eddies to 1.11 m/s at the upstream reaches in the thalweg. Water depth within the riffles was about 0.30 m and water temperature ranged from 9.4 to 9.9 degrees Celsius. Below I have included a photo from a similar vantage point for 2019 (left) and 2018 (right) in Reach 2 of Lower Sherlett Creek for reference;

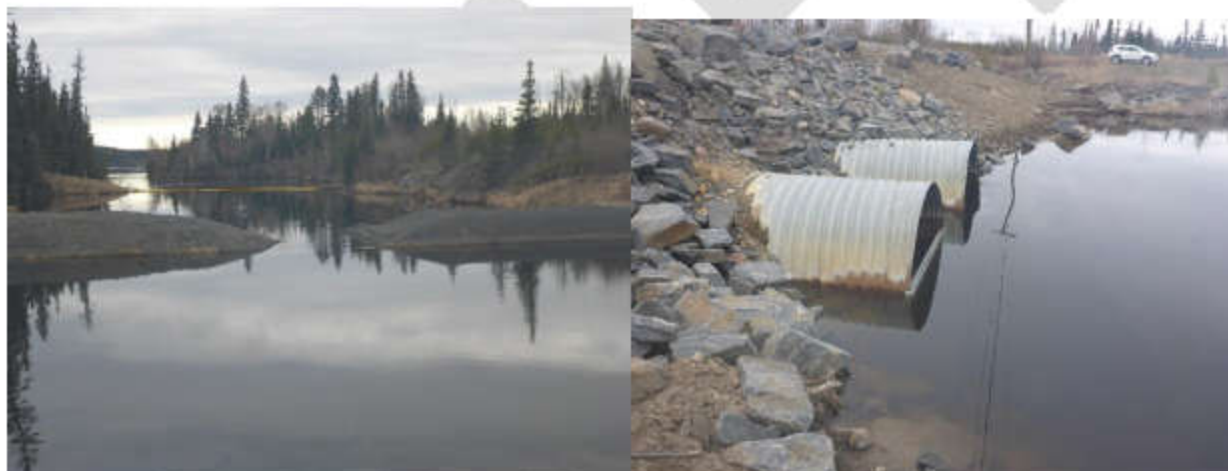
- Approximately 30 Walleye on each night (in spawning condition – looked to be mostly males) and 100's of White Sucker and Longnose Sucker also in spawning condition were observed staging in all reaches of the creek as well as upstream all the way to the stop log control structure at the outfall of Sherlett Lake;
- Fish were also observed staging at the newly notched cofferdam into Camp Lake. The capped culverts into the diversion channel seemed to be functioning well (pictures below);

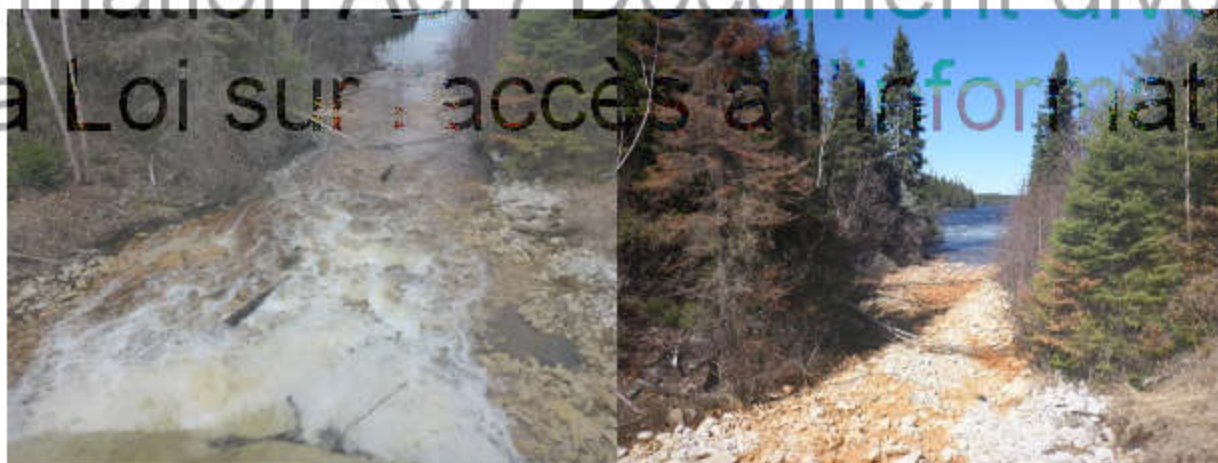
- The newly opened outlet to Camp Lake was also flowing at a steady rate and sucker and one Northern Pike were staging below the outlet. Below is a photo from 2019 (left) and 2018 (right);

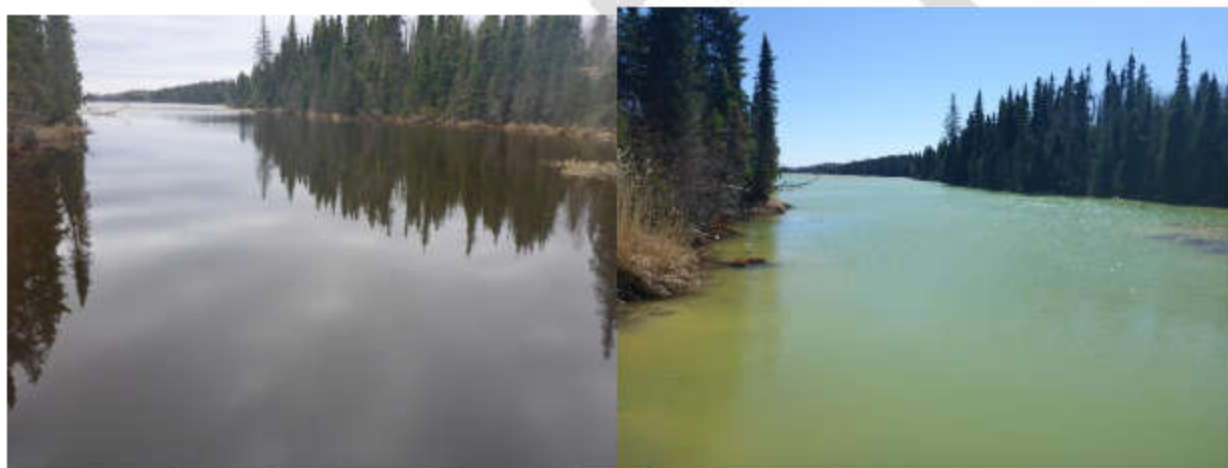
- Finally, there was an observable difference (visually) in water quality in 2019 (left) versus 2018 (right) in Camp Lake since water had been diverted;
